Manhole Inspection Summary

Manhole # S23I__019MH

Location Address: **31 S Morris St**

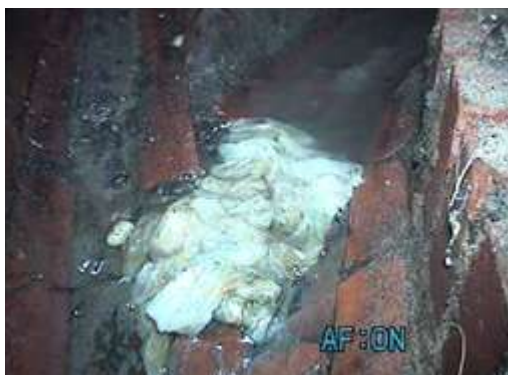
MISCELLANEOUS

debris in channel

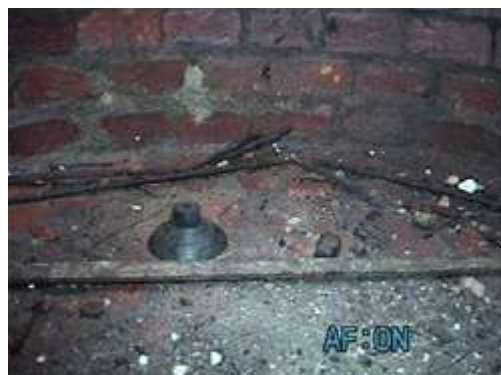
MISCELLANEOUS

debris on bench

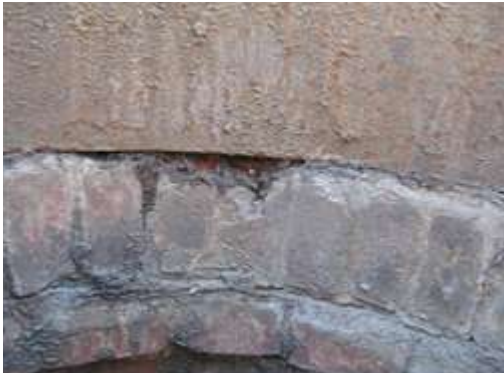
Defect 1

Frame Offset: **0** (in.) Condition: ☐ Sound ☐ Cracked ☒ **Leaks**

Infiltration: ☐ None ☒ **Joint** ☒ **Cracks** ☐ Mortar ☐ Roots ☐ Wall

infiltration frame-chimney

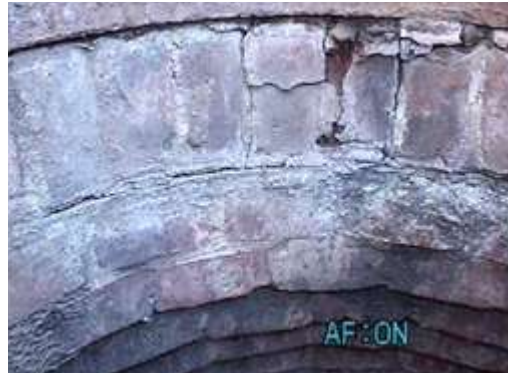
Defect 3

Condition: ☐ Sound ☒ **Cracked** ☐ Root Intrusion ☐ Loose Brick ☒ **Deteriorated**

cracked and deteriorated chimney

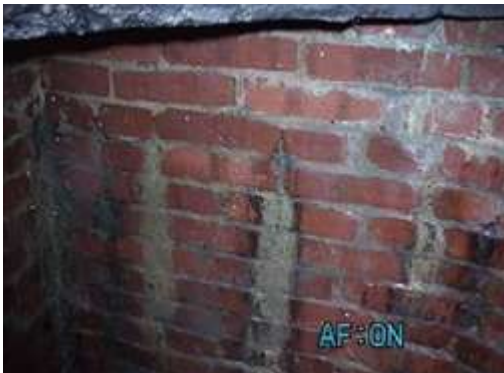
Defect 2

Infiltration: ☐ None ☐ Joint ☐ Cracks ☐ Mortar ☐ Roots ☒ **Wall**

infiltration barrel-corbel area
